## An uncommon localisation of a vegetal foreign body in a dog: a case report

**ABSTRACT:** The goal of this study was to describe the ultrasonographic and computed tomographic appearance of a penile foreign body in a dog for the first time. We describe an unusual penile localisation of a grass seed awn in an 11-year-old mixed-breed dog referred for a computed tomography study after a severe haemorrhage from the penis. A fistulous tract was observed after plain and post-contrast whole-body computed tomography acquisition; the foreign body was localised with ultrasound and removed under ultrasonographic guidance, with the complete healing of the penile lesion. Grass awns are common foreign bodies in dogs and cats and are commonly localised in the ear canal, subcutaneous tissue, interdigital space, eyelid, conjunctiva and nasal or oral cavity. These foreign bodies pose a threat due to their peculiar structure, which facilitates their easy access to the affected area and their transit through the body. Clinical signs are often non-specific, and imaging modalities such as ultrasonography and computed tomography are useful techniques for localisation. Our report demonstrates that the c

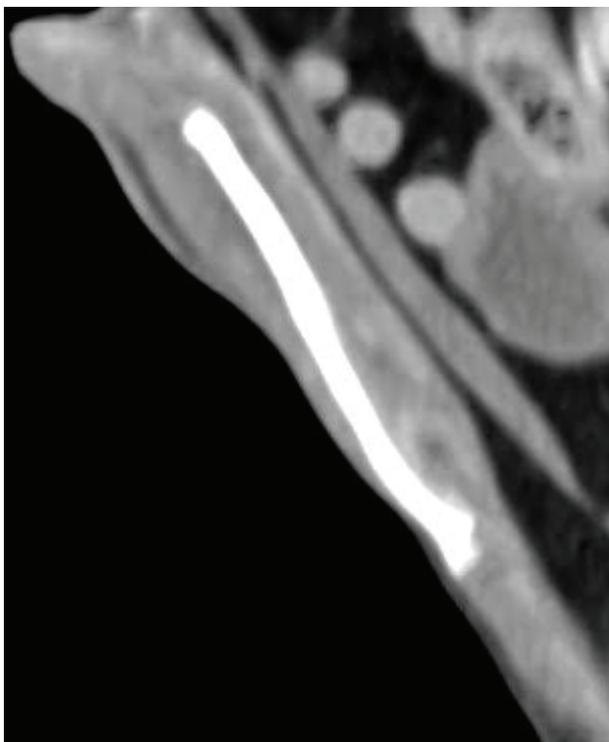
Figure 1. Computed tomography image of the fistulous tract

Plain and post-contrast computed tomography were performed with a multidetector computed tomography scan (BrightSpeed, Milwaukee, USA). The post-contrast computed tomography acquisition showed a fistulous tract, with a hyperattenuating and irregular wall in the left cavernous body of the penis, at the level of the caudal border of the *os penis* (Figure 1). A neoplastic lesion was excluded on the basis of computed tomography findings and, as differential diagnosis, a foreign body in the penis was considered. During preparation for ultrasound under anaesthesia, a small round lesion was visible dorsally and at the base of the penis, probably at the exit of the fistulous tract (Figure 2). Ultrasound showed a linear spindle-shaped hyperechoic structure localised in the caudo-dorsal part of the penis (Figure 3). The entire foreign body (Figure 4) was then successfully extracted under ultrasound guidance with a Hartmann forceps, and the lesion completely healed without further complications.

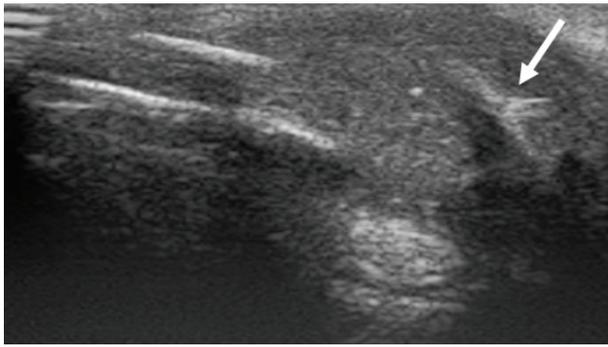
Figure 3. Ultrasound image of the penis in sagittal plane; a V-shaped hyperechoic structure is visible, corresponding to a vegetal foreign body (arrow)
